Time-Variant Structural Performance of the Certosa Cable-Stayed Bridge

Fabio Biondini, Assoc. Prof., Politecnico di Milano, Milan, Italy; **Dan M. Frangopol**, Prof. and F. R. Khan Endowed Chair of Structural Engineering and Architecture, Lehigh University, Bethlehem, Pennsylvania, USA – formerly, Prof., University of Colorado, Boulder, Colorado, USA; **Pier Giorgio Malerba**, Prof., Politecnico di Milano, Milan, Italy

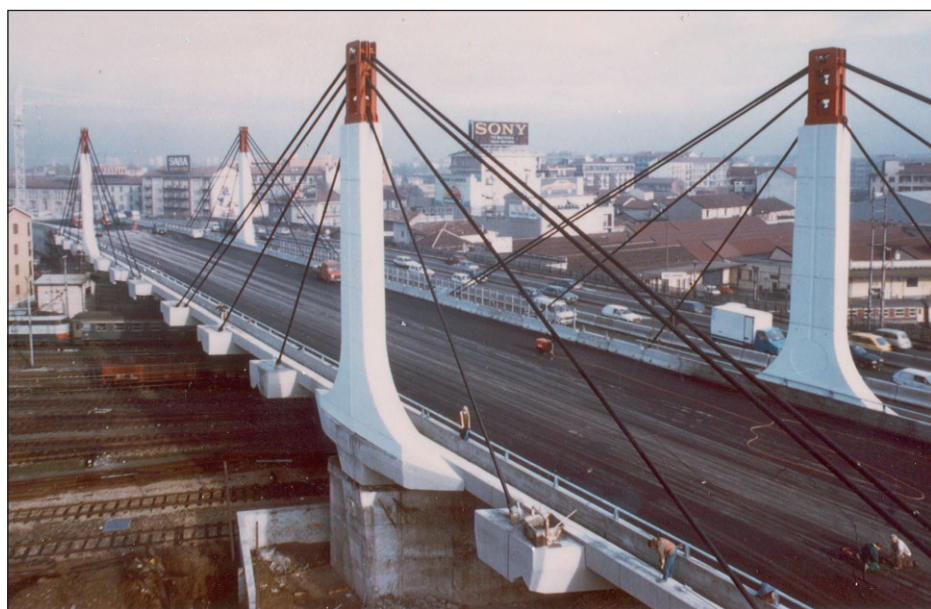
Fig. 1: View of the Certosa cable-stayed bridge

This study is concerned with the Certosa cable-stayed bridge built in Milan, Italy (Fig. 1). Since its pylons showed some traces of damage, a rehabilitation intervention has been carried out after fifteen years of lifetime. In order to investigate the effectiveness of the rehabilitation, the time-variant performance of the pylons is evaluated in both deterministic and

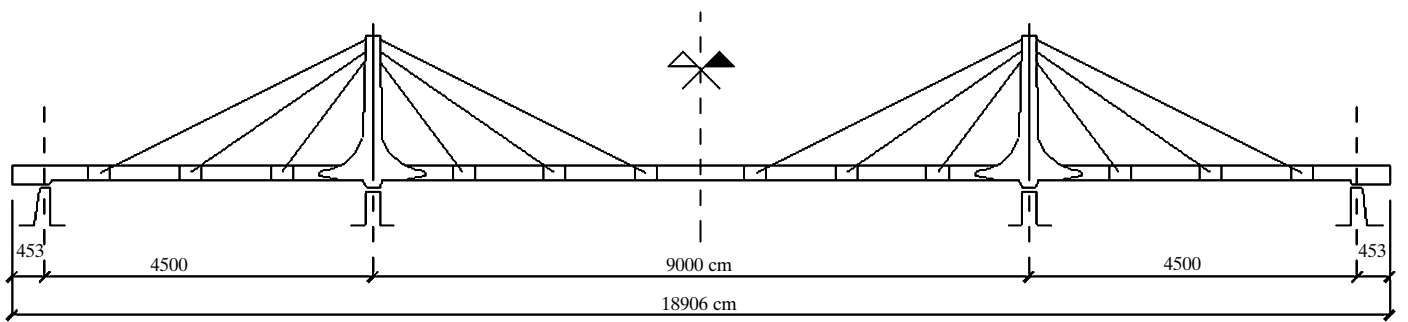
(a) Main dimensions of the bridge

Several design alternatives were examined. Among them, a solution based on a cable-stayed bridge with three spans of 45-90-45 m (Fig. 2a) and with a deck 1,60 m deep (Fig. 2b, c, d) was finally selected. The suspension system is fan-shaped and consists of 8 stays for each pylon. The height of the two pylons

The total length of the bridge is 180 m, with a central span of 90 m and two lateral spans of 45 m, as shown in Fig. 2a. The bridge deck is a five cells box girder, 19,80 m wide and 26,7° skewed with respect to the road axis. The transversal section has a depth varying from 1,40 m to 1,80 m and the upper slab has the same small transversal

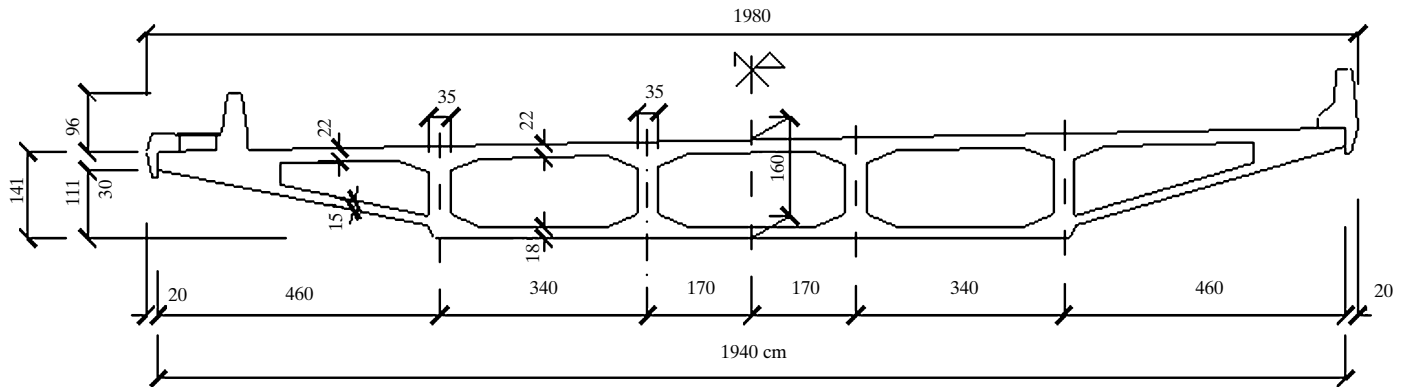
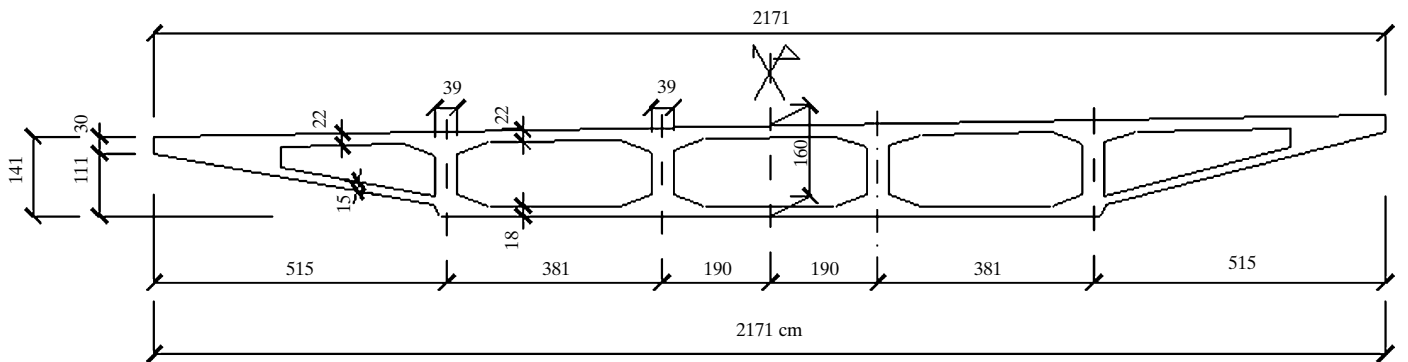
(b) Straight cross-section of the deck

(c) Skewed cross-section of the deck

slope as the road (Fig. 2b,c). The upper and lower slabs are 0,22 m and 0,18 m thick, respectively. Along its span the box is stiffened by a set of transversal beams (Fig. 2d), placed in correspondence to the stays. Such beams finish with two short cantilevers to which the stays are anchored. The transversal beams over the piers are deeper than the others, to hold the high forces transmitted by the pylons. The deck and the beams are prestressed with cables made up of 14 and 19 strands of 0,6 inches.

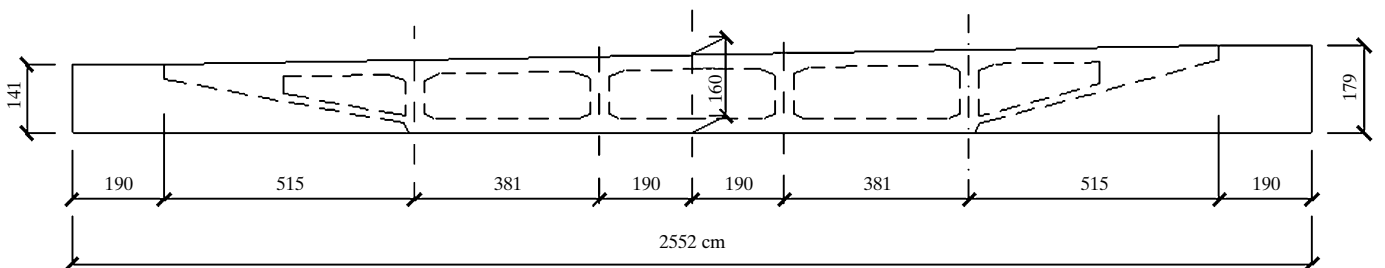
(d) Skewed cross-section on the transversal beam with the heads of the cable anchorages at the ends

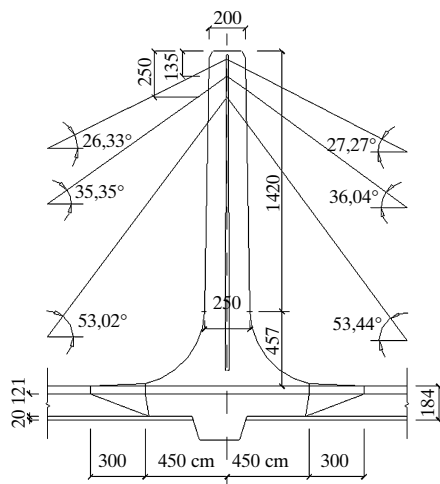
(a) Main geometrical dimensions

The pylons of the cable-stayed bridge are 19,00 m high and have a rectangular cross-section, varying along the height from $1,14 \times 2,00$ m at the top to $1,14 \times 2,50$ m at the bottom (Fig. 3a). The tapered shape of the frontal view finishes in two corbels, which were planned to lift the bridge. The ends of the pylons carry the devices used to anchor the stays. There are in total three seats consisting of steel boxes, which make it possible to anchor the stays leaving them, crossed but not intersected on the same plane.

Each pylon has three pairs of stays, skewed with respect to the horizontal plane as shown in Fig. 3a. The stays are composed, the longest to the shortest, by 2×45 , 60, 45 strands of 0,6 inches. The prestressing of the stays was defined to balance the time dependent effects associated to creep and shrinkage of the concrete deck [7]. The stress in the stays under dead loads is then expected to be nearly constant in time.

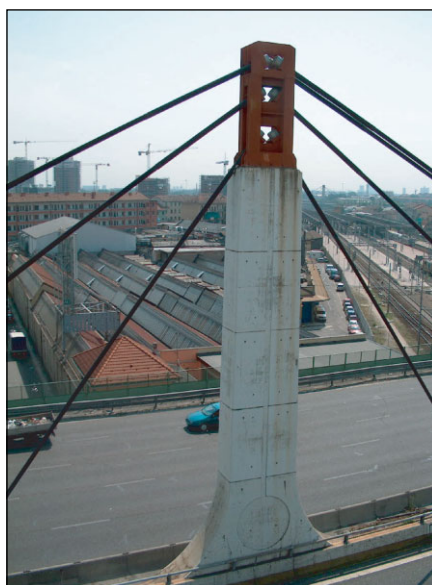
(b) View of a pylon after 15 years of lifetime

After about fifteen years of service, the Milan Municipality decided for a general and detailed inspection of the bridge. The accurate design of the shape of the surfaces and the care spent in the reinforcement detailing, in the determination of an adequate cover thickness and in the choice of effective surface protective materials have contributed to the conservation of this bridge. Even though the structure had to withstand the severe loading conditions acting on the most important and busy access to Milan, it was in general in a good state. The deck was intact and presented surfaces without cracks, spallings or salt patches. Traces of damage were visible on the most exposed parts, including the four pylons, surrounded by the wind flow and subjected to the flow of acid rain and to the attack of aggressive materials coming from both the road and the underlying railway (Fig. 3b).

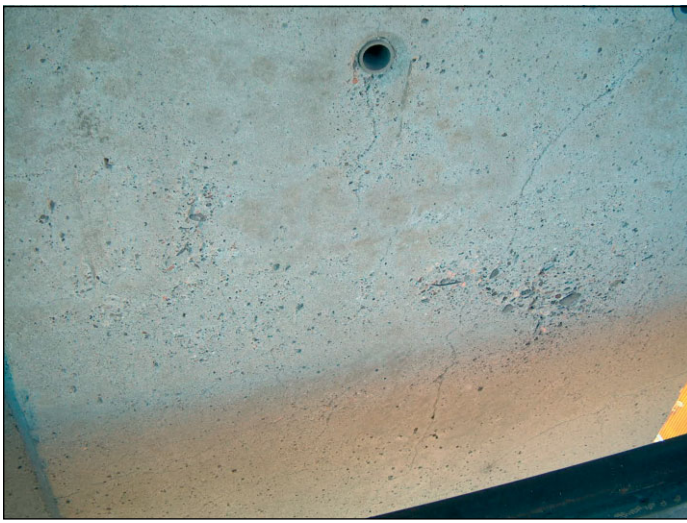
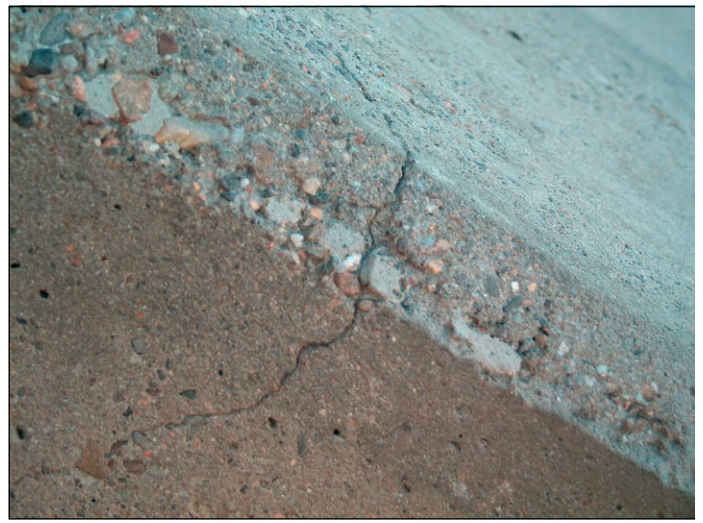
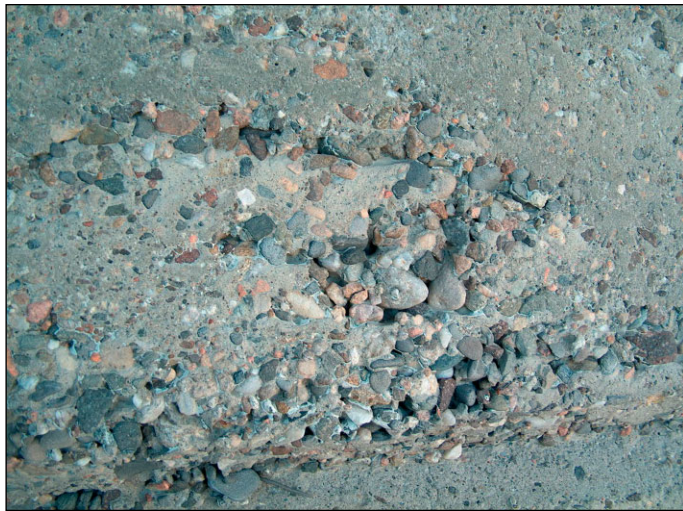
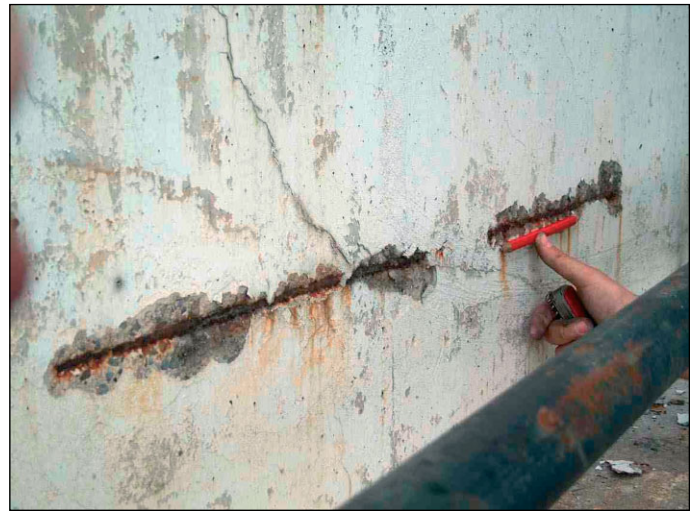
Fig. 4: Traces of structural damage of the pylons revealed by the inspection activities

(a) Randomly distributed cracks

(b) Localized crack

(c) Aggregate segregation

(d) Spalling and initial steel corrosion

The first inspections revealed that some dramatic appearances of the surface crack patterns were due mainly to the traces of a mix of oil and dust retained by the lips of paint skin, delaminated from the concrete surface. The local removal of the paint revealed (a) small size reticulates of cracks, marked by dark contours but without a measurable width and (b) small width cracks randomly distributed (Fig. 4a). These effects can be attributed to the plas-

tic shrinkage and to the water loss during the first phases of the curing process. Cracks of same importance have been detected close to massive casts (Fig. 4b) and to the boundaries of the second phase completion casts. After a strong sandblasting cleaning (Fig. 5a), a set of carbonation and hardening tests have been carried out. During these activities it was not possible to take out boring samples. The depth of carbonation resulted in accordance with the expected values on a 15 year old structure (min. 6,7 mm, max. 20,5 mm, average value 10,3 mm). The rebound hammer tests provided medium/high values of the RH index (min. 43,89; max. 57, average value 50,17). At the basis of the cast interruption some aggregate segregation has been detected, but with the aggregates strongly adherent among themselves through the residual cement paste (Fig. 4c). Spalling and initial steel corrosion have been detected only at the lower external parts of the pylons, which are directly exposed to traffic emissions (Fig. 4d).

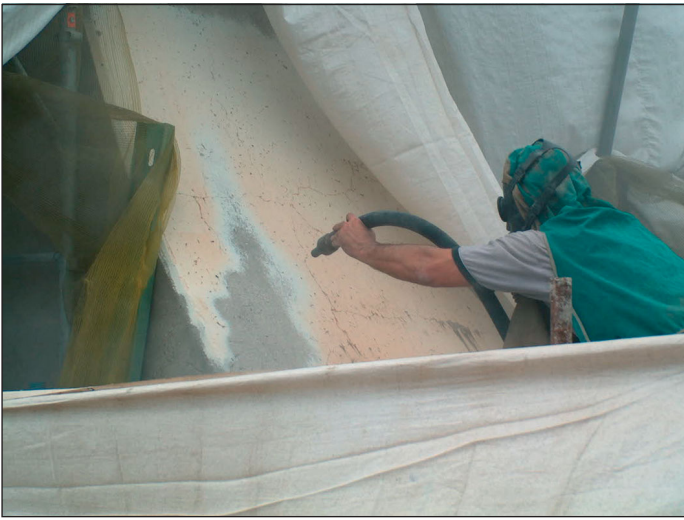
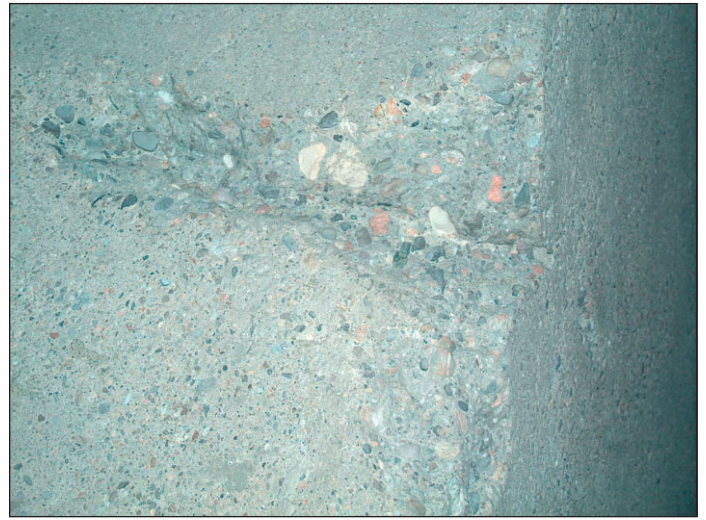
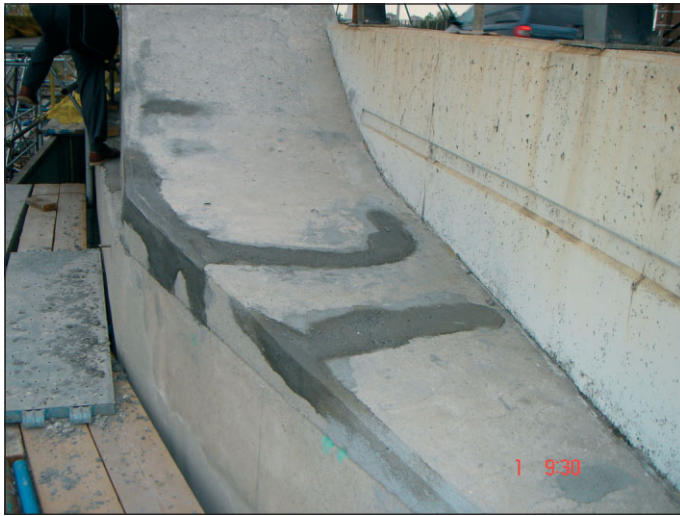
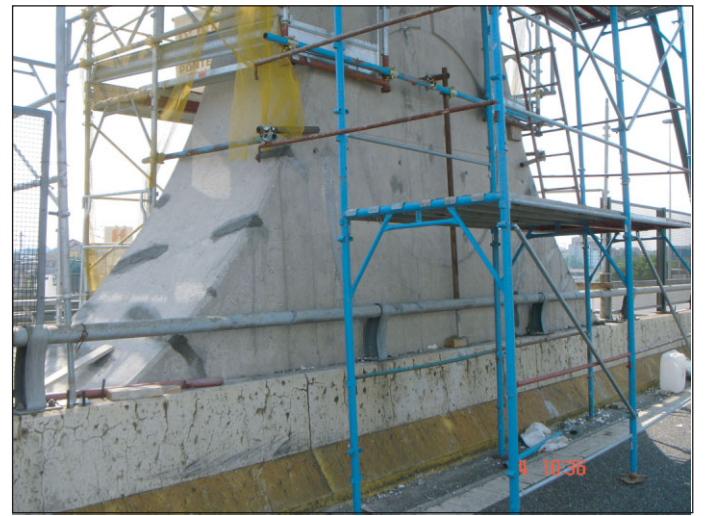
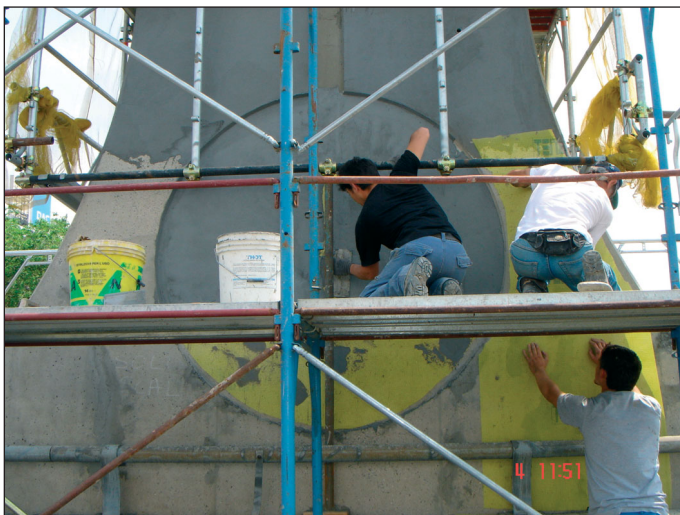
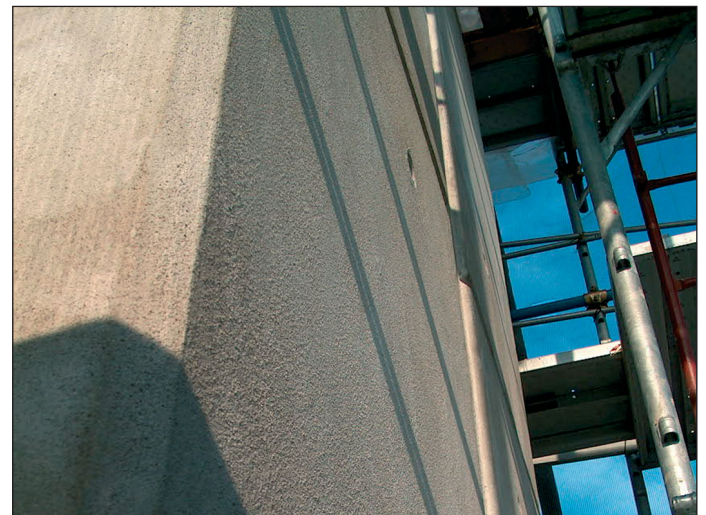
Fig. 5: Repair of the whole surfaces of the pylons

(a) Sandblasting

(b) Local curving up to the basis of the crack

(c) Local sutures with tixotropic, anti-shrinkage, polypropylene fiber reinforced mortar

(d) Small local damage (segregation, small cracks) repairs with high adhesion cement mortar, added with polyvinilalcohol fibers

(e) Skin protection with high adhesion elasticity sealing cement mortar, reinforced with double or simple skin mesh

(f) Pylon surface after skin protection

The guideline of the rehabilitation operations is summarized herein. The main cracks have been curved up to the basis of the crack (Fig. 5b) and then sutured with tixotropic, anti-shrinkage, polypropylene fiber reinforced high strength mortar (Cubic Compression Strength $R_{28} > 55,2$ N/mm². Flexural Strength $> 11,1$ N/mm²) (Fig. 5c). The small cracks and the segregation zones have been repaired with high adhesion cement mortar, added with small polyvinilalcohol fibers (Adhesion Strength $> 3,0$ N/mm²) (Fig. 5d). The whole skin surfaces have been protected with high adhesion, high elasticity cement mortar ($E_{28} = 9000$ N/mm²), reinforced with double or simple skin mesh (Fig. 5e). This protection contributes to contrast the restart of carbonation and it is transpiring outward and waterproof inward. The final surface was painted with a silicate non-pellicular paint that is also transpiring outward and waterproof inward (Fig. 5f). In this way, future diffusive attacks of external aggressive agents are prevented. Finally, also a detailed inspection of the head anchorages has been carried out (Fig. 6a). The steel anchorage assembly has been painted with a 65 μ m enamel composed by polyuretanic resins (Fig. 6b). Fig. 7 shows a global view of a pylon after the rehabilitation interventions.

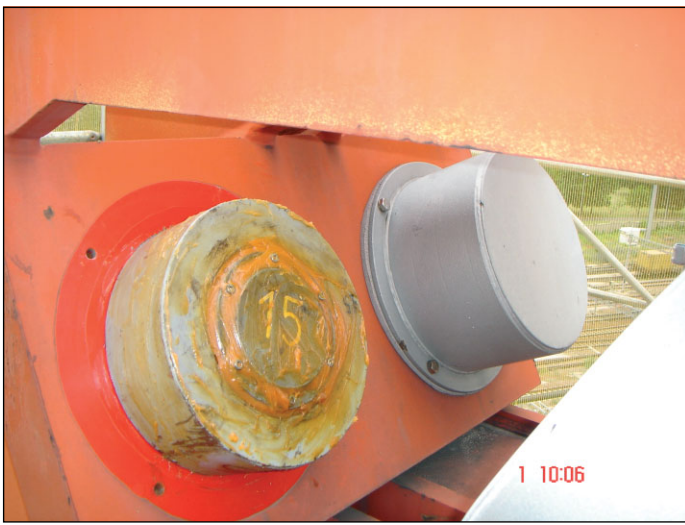
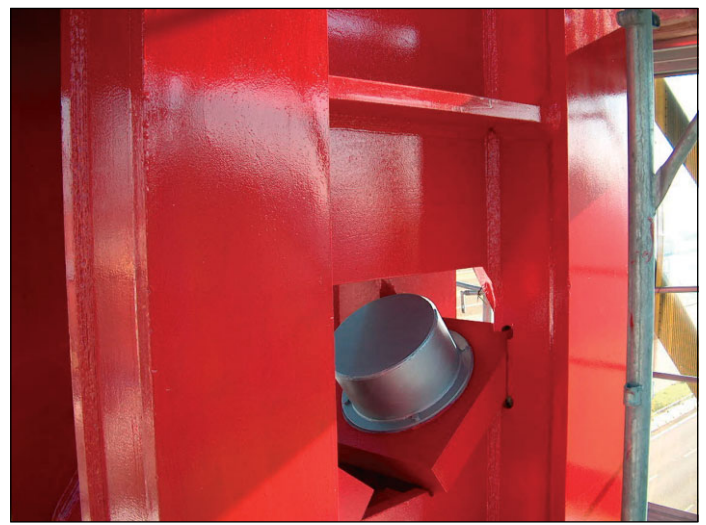
Fig. 6

(a) Head of the anchorage cable inspection

(b) Detail of the anchorage assembly after painting

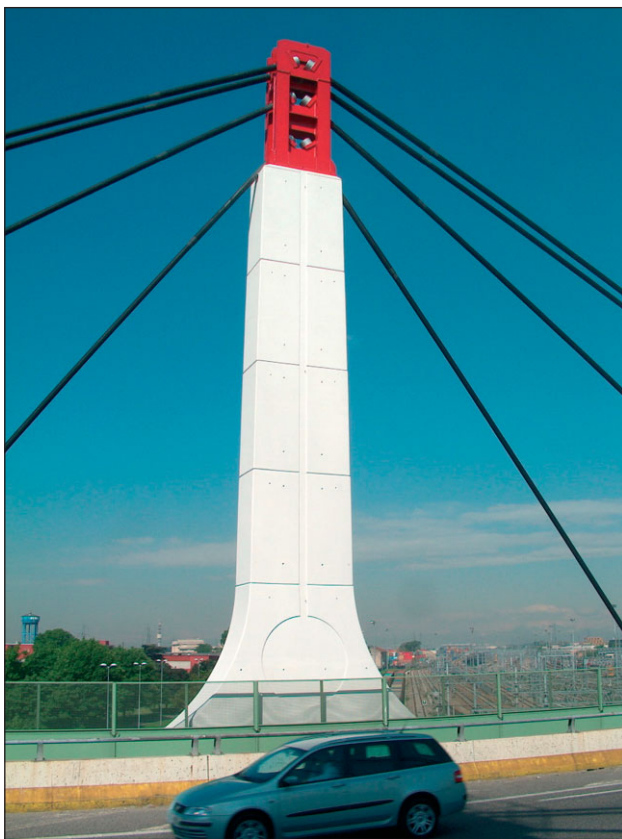
Fig. 7: View of a pylon after the rehabilitation intervention

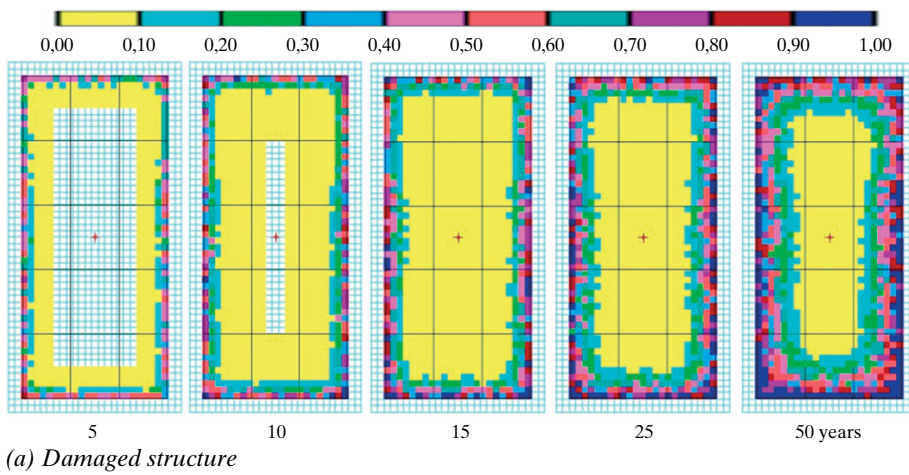
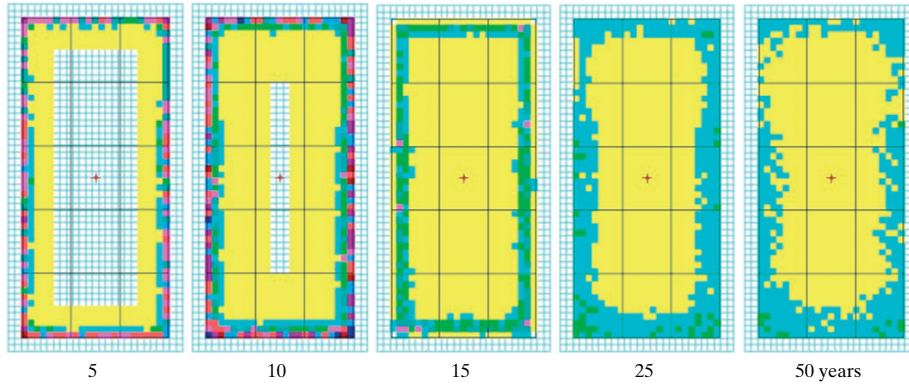
(a) Damaged structure

(b) Rehabilitated structure

Fig. 9: Maps of concentration $C(\mathbf{x},t)/C_0$ of the aggressive agent after 5, 10, 15, 25, and 50 years from the initial time of diffusion penetration

The diffusion process associated with the two investigated scenarios, without and with rehabilitation intervention, is described by the maps of concentration $C(\mathbf{x},t)/C_0$ of the aggressive agent shown in Fig. 9. The direct comparison of the concentration maps in Fig. 9a and 9b highlights the high effectiveness of the rehabilitation intervention with regards to the limitation of the diffusive attack of the aggressive agent.

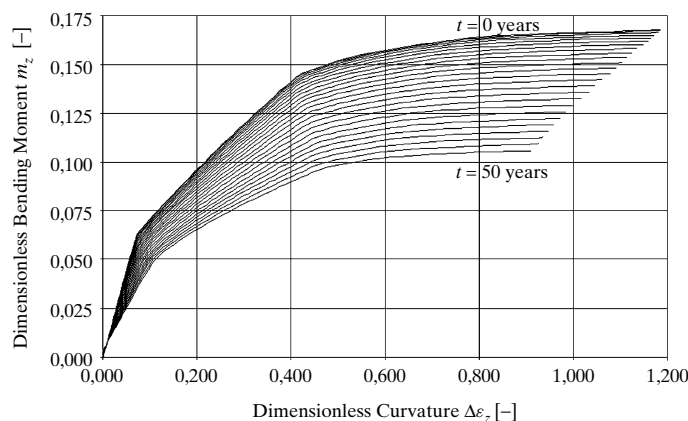
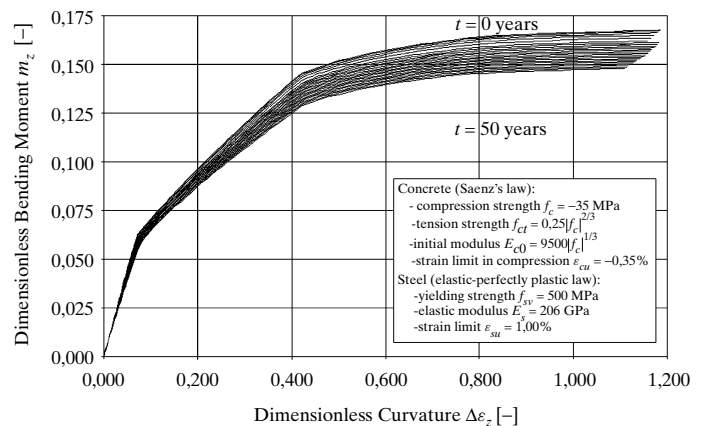
(a) Damaged structure

(b) Rehabilitated structure

Fig. 10: Time evolution of bending moment $m_z = M_z / (f_c A_{c0} d_y)$ / curvature $\Delta \varepsilon_z = 100 \chi_z d_y$ diagrams during the first 50 years of lifetime ($\Delta t = 2$ years)

The mechanical damage induced by diffusion can be evaluated from Fig. 10, which shows for the two investigated scenarios the time evolution of the dimensionless bending moment $m_z = M_z / (f_c A_{c0} d_y)$ versus curvature $\Delta \varepsilon_z = 100 \chi_z d_y$ diagrams under the axial force $n = N / (f_c A_{c0}) = -0,201$, where $N = -20$ MN. The nominal values of the main parameters which define the non-linear constitutive laws of the materials are also listed in Fig. 10b. The direct comparison of the diagrams in

Fig. 10a and 10b highlights the high effectiveness of the rehabilitation intervention with regards to the degradation of the structural performance induced by the aggressive agents.

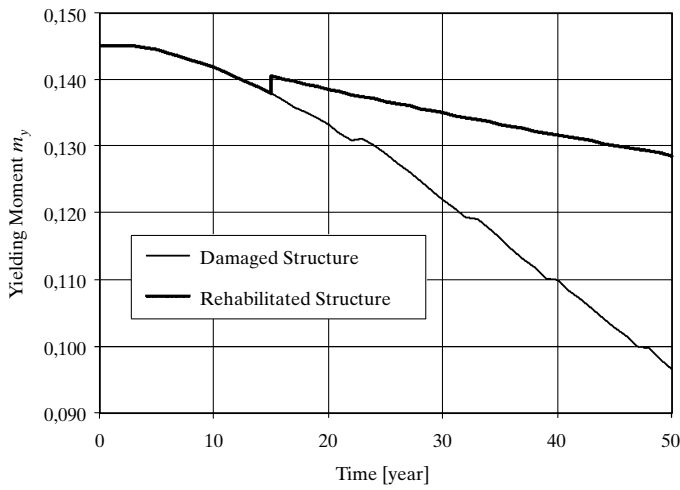
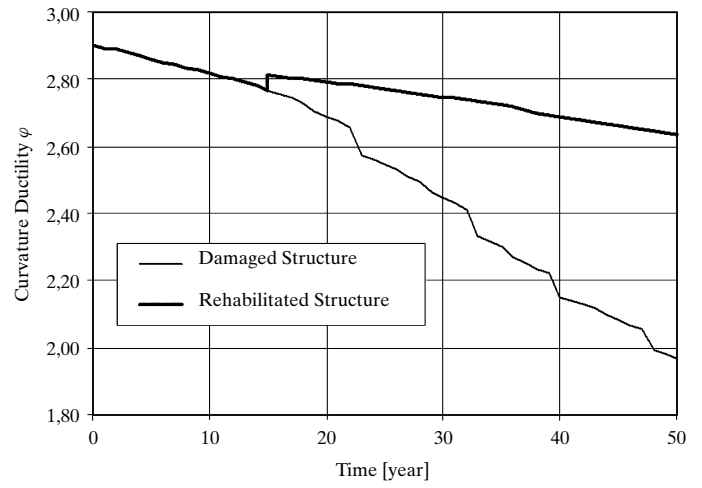
(a) Yielding moment

(b) Curvature ductility

Fig. 11: The realization of a single sample of time evolution

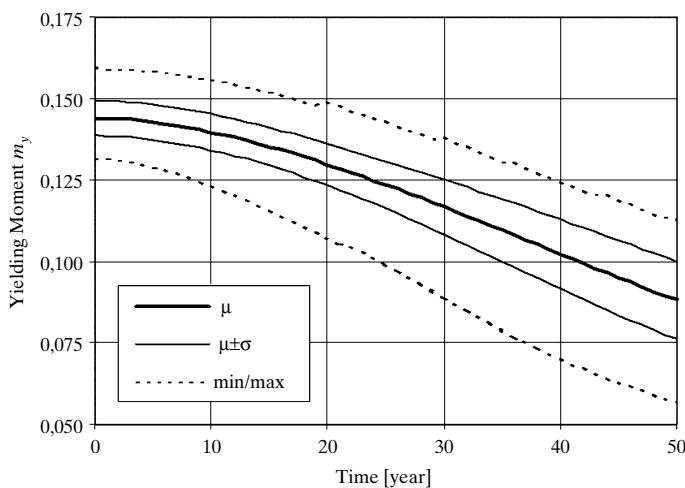
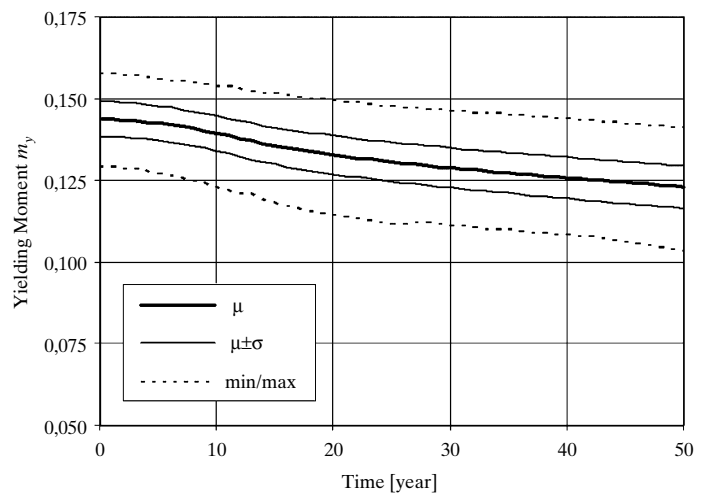
(a) Damaged structure

(b) Rehabilitated structure

Fig. 12: Time evolution of the yielding bending moment: mean μ (thick line), standard deviation σ from the mean μ (thin lines), minimum and maximum values (dotted lines)

the two investigated scenarios, Figs. 12 and 13 show the time evolution of the statistical parameters (mean value μ , standard deviation σ , minimum and maximum values) of the performance indicators during the first 50 years of service life. The direct comparison of Figs. 12a and 12b, as well as of Figs. 13a and 13b, demonstrates the high effectiveness of the adopted rehabilitation intervention. In particular, it can be noted that the effects of randomness lead (a) to reduce the magnitude of the instantaneous increase of structural performance, especially in terms of yielding moment, and (b) to better emphasize the delayed beneficial effects of rehabilitation. In fact, beside a relevant increase of performance over time in terms of both yielding moment and curvature ductility, a noteworthy decrease in the dispersion of the yielding moment is achieved.

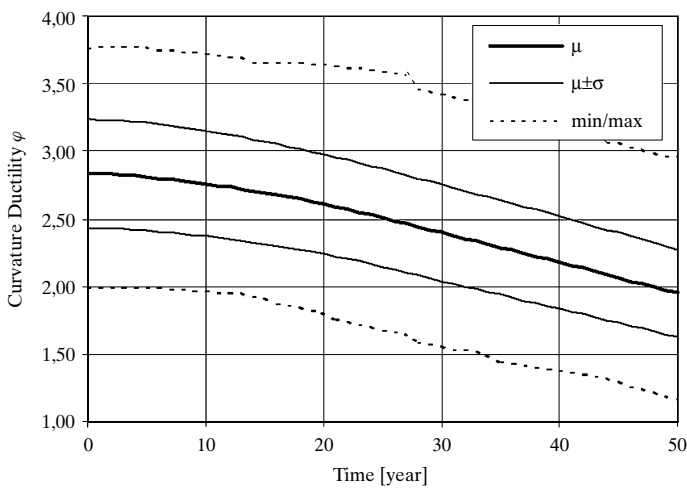
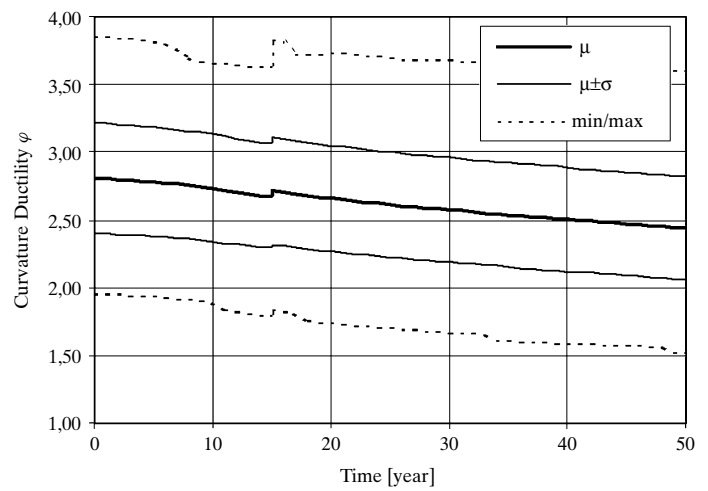
(a) Damaged structure

(b) Rehabilitated structure

Fig. 13: Time evolution of the curvature ductility: mean μ (thick line), standard deviation σ from the mean μ (thin lines), minimum and maximum values (dotted lines)

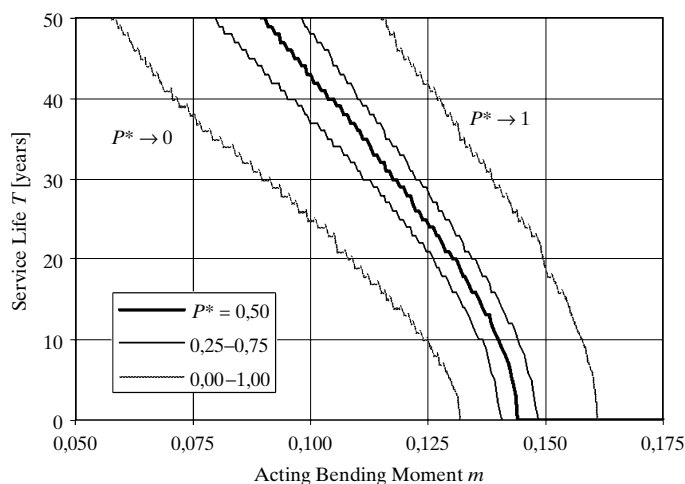
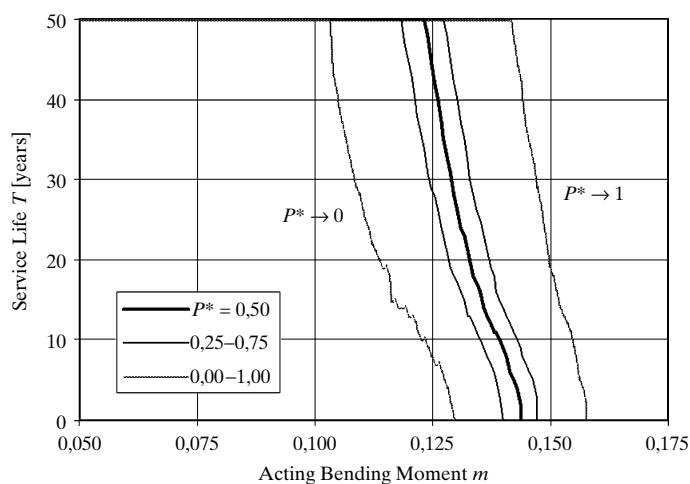
(a) Damaged structure

(b) Rehabilitated structure

Fig. 14: Service life associated with prescribed values of probability of failure P^* versus given target levels of the yielding bending moment

where t_0 is the time instant at the end of the construction phase. Figs. 14 and 15 show the service life T associated with the five reliability levels $P^* = [0,00, 0,25, 0,50, 0,75, 1,00]$ as a function of the expected values of the performance indicators. These curves allow to assess the remaining service life which can be assured under prescribed reliability levels without maintenance. The direct comparison of Figs. 14a and 14b, as well as of Figs. 15a and 15b, shows how the rehabilitation intervention is able to extend the service life of the structure. As an example, for a dimensionless acting bending moment $m \cong 0,10$ and a failure probability threshold $P^* \rightarrow 0$, the service life is extended from $T \cong 25$ years (Fig. 14a) to $T \cong 50$ years (Fig. 14b).

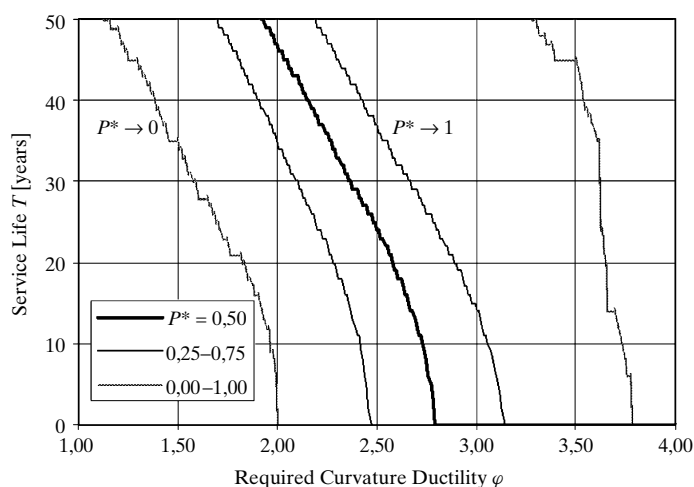
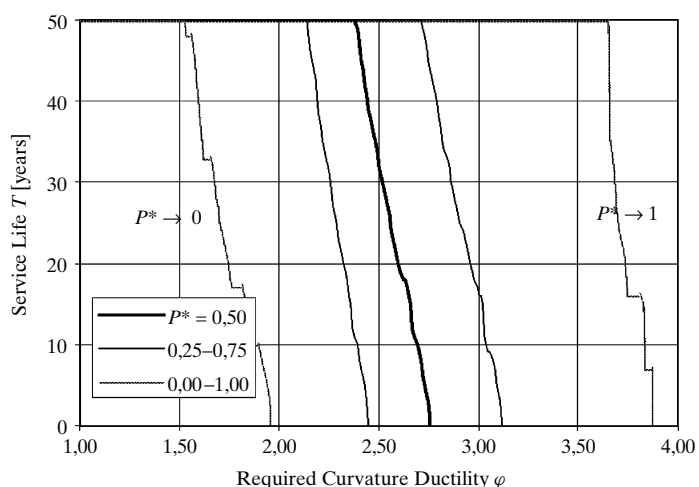
(a) Damaged structure

(b) Rehabilitated structure

Fig. 15: Service life associated to given values of probability of failure P^* versus given target levels of the curvature ductility
